Property Inspection Report

1234 Celebration Lane, Big City, FL 33333
Inspection prepared for: Mr. and Mrs. America
Real Estate Agent: Agent Amazing - Greatest Realty Company

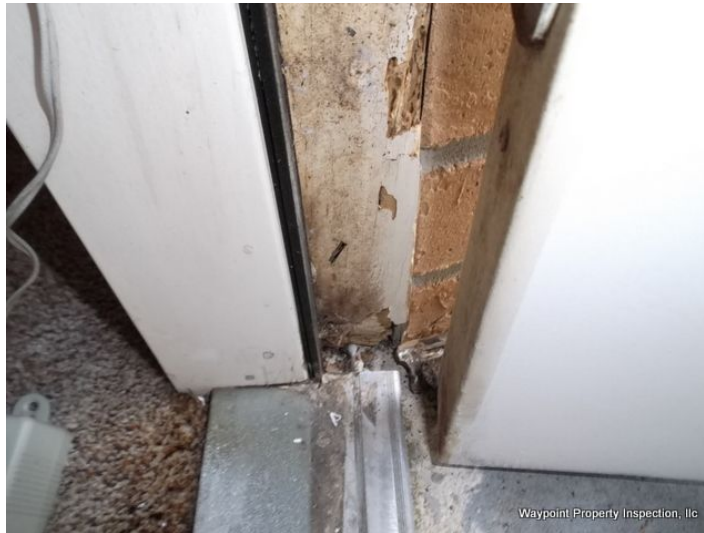
Moisture and WDO like damage visible at secondary door(s) jamb. Recommend evaluation by WDO licensed tradesman.

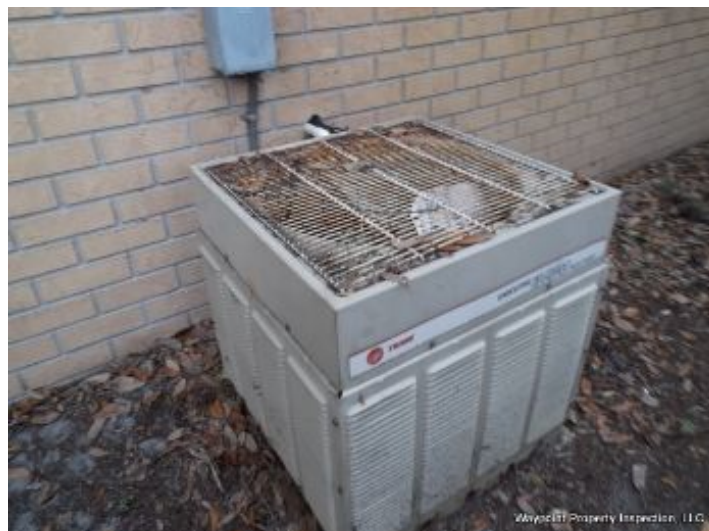
Cooling system 1 has surpassed its manufacturer's life expectancy (12 - 15 years.) Suggest full evaluation by a qualified HVAC specialist.

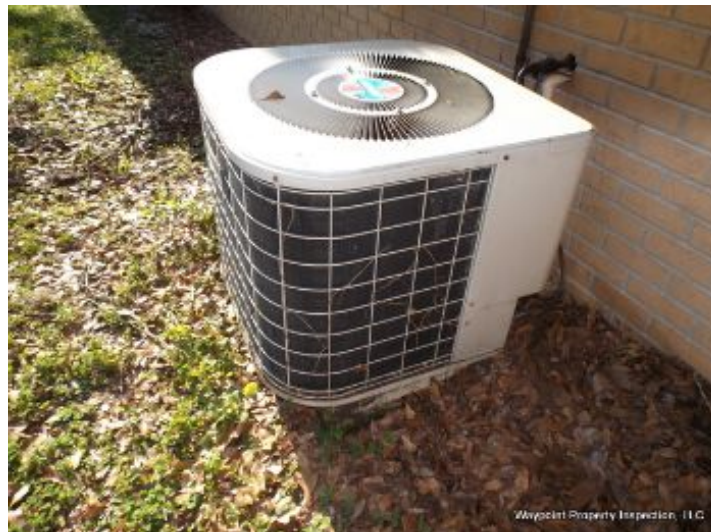
Air temperature differential is 15 degrees. Per manufacturer guidelines, normal range is 14-22 degrees.

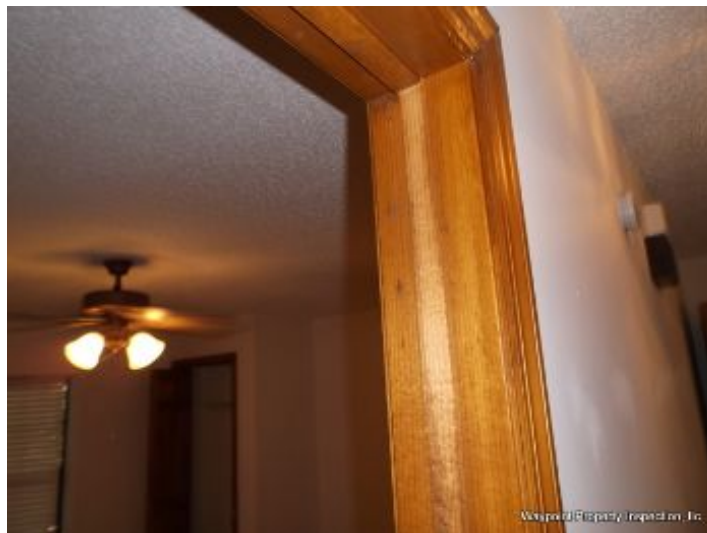
Missing trim at secondary bedroom.

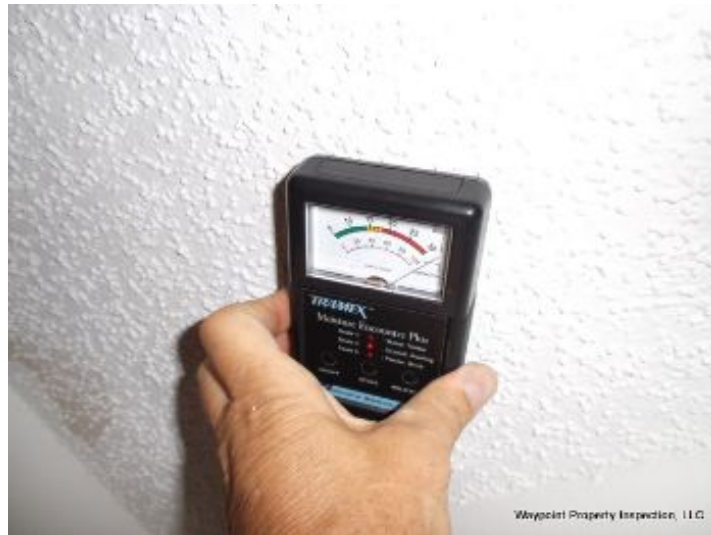
Moisture detected at South hallway. See attic notes.

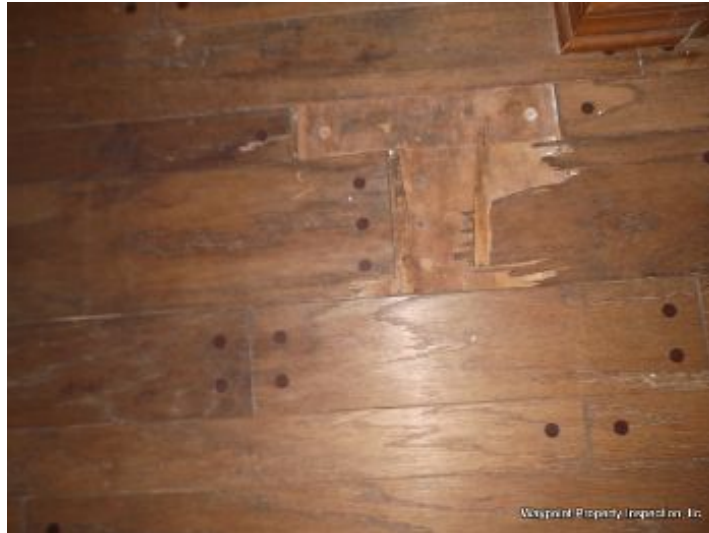
Damage visible at wood flooring.

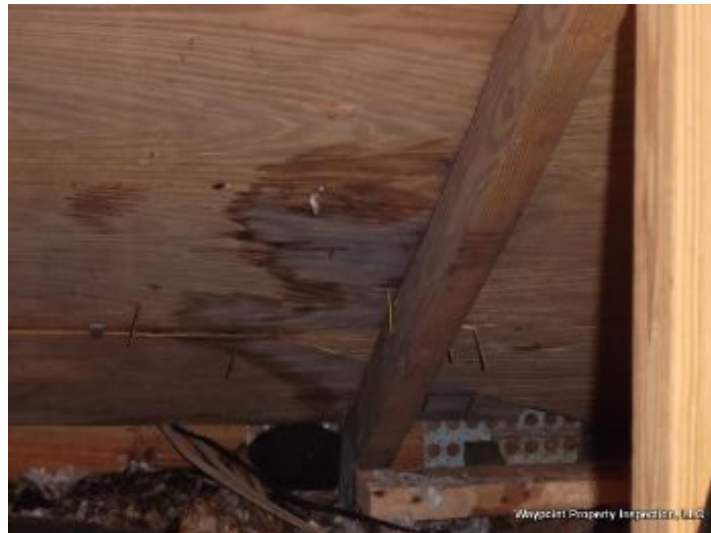
Moderate stains/damage visible at South hallway. Tested wet. Suggest evaluation and repair.

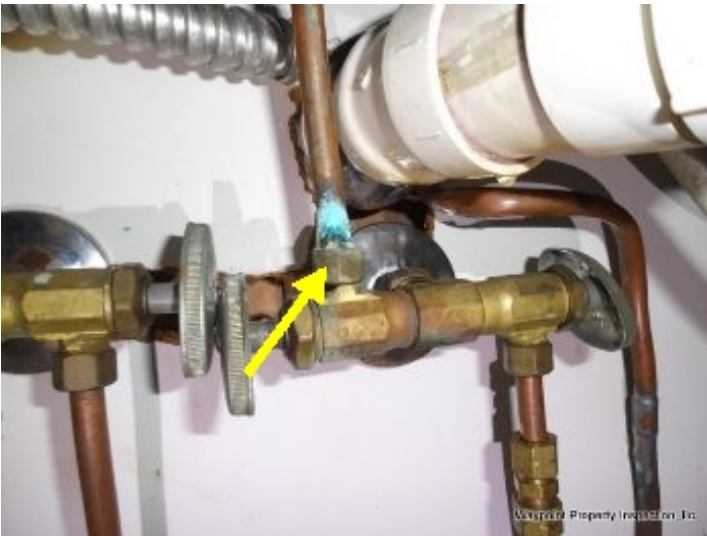
Pipes under kitchen sink are corroded.

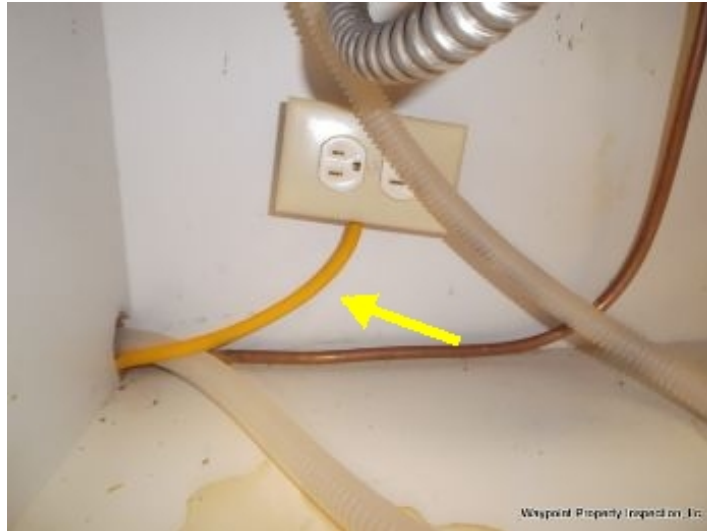
Romex wiring below the sink is exposed. Wiring should be placed in protective electrical conduit to prevent shock hazard.

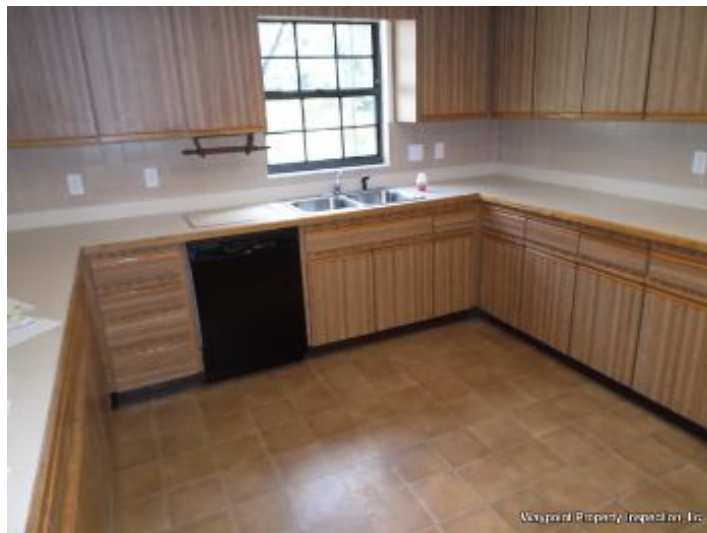
Moderate wear present at cabinets.

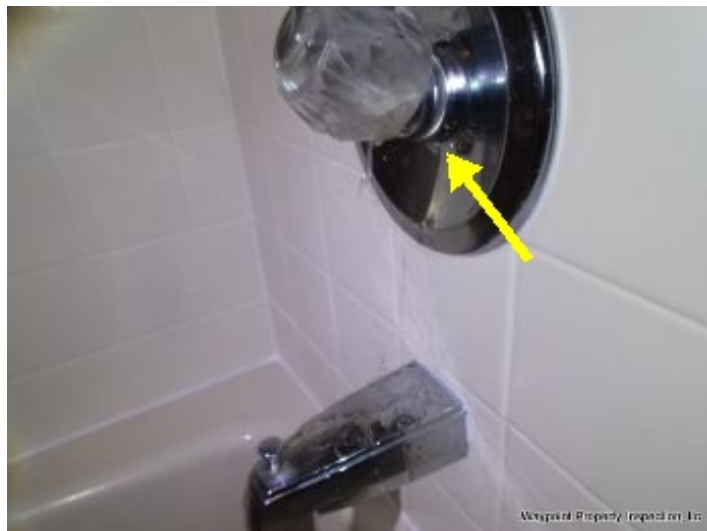
Faucet control leaks at master bathroom.

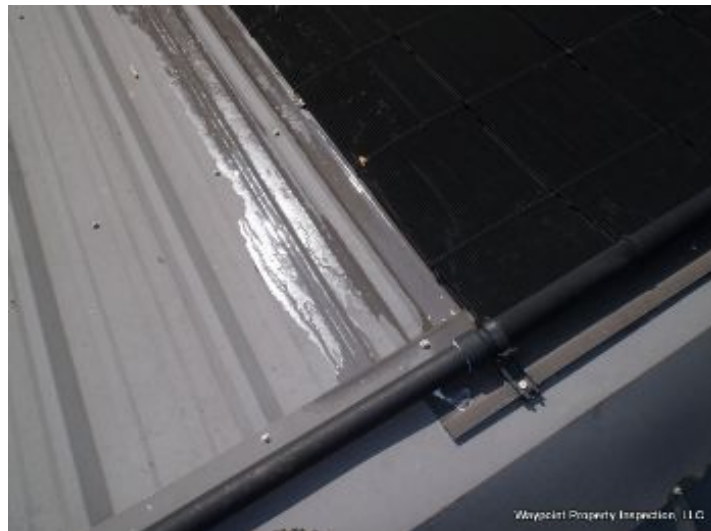
Solar panels are leaking.
